PHOTOGRAPHIC DOCUMENTATION AND OBSERVATIONS REPORT

DATE: February 22, 2011

SITE: Jervis B. Webb Co.

EPA ID: CAD008339467

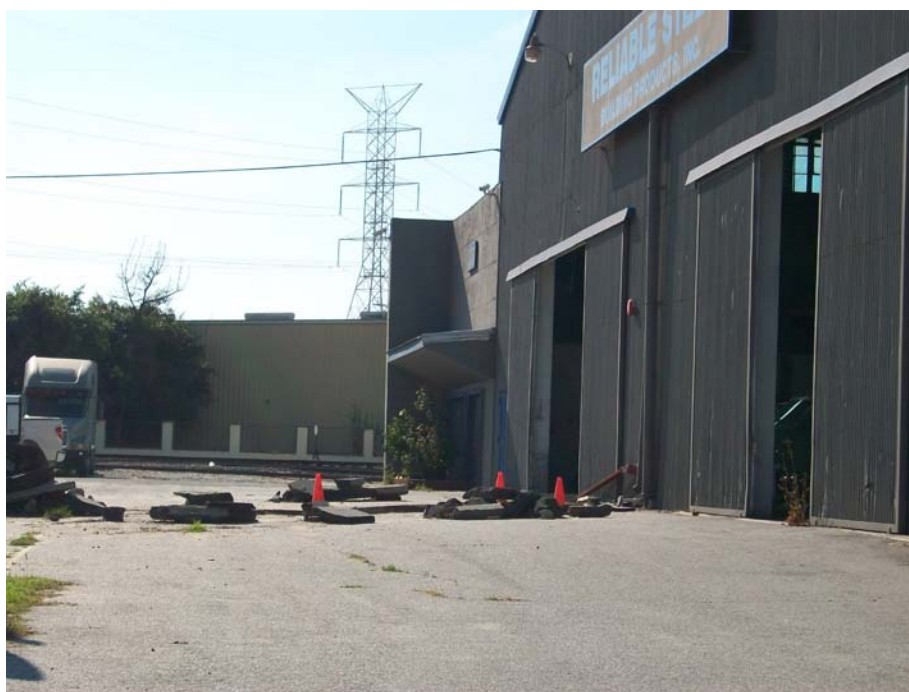
Photograph 1: Jervis facility, currently occupied by Reliable Steel. Cracks in the pavement containing vegetation are seen in the center and along the left border of the photograph. Due to the poor condition of the pavement, precipitation could infiltrate the contaminated soil beneath.

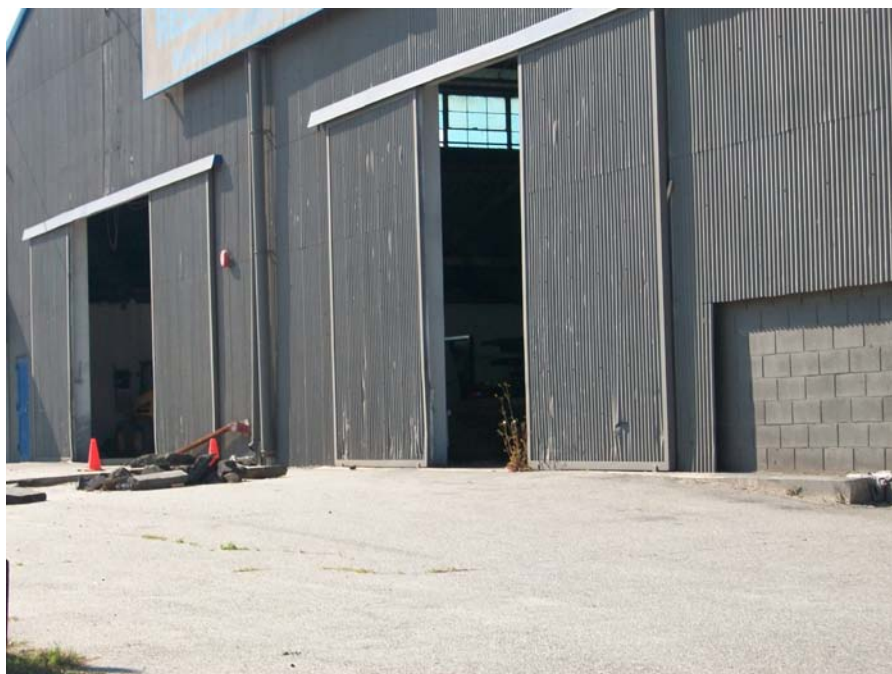
Photograph 2: Jervis facility, currently occupied by Reliable Steel. Cracks in the pavement containing vegetation are seen in the center of the photograph and in the warehouse entrance. Due to the poor condition of the pavement, precipitation could infiltrate the contaminated soil beneath.

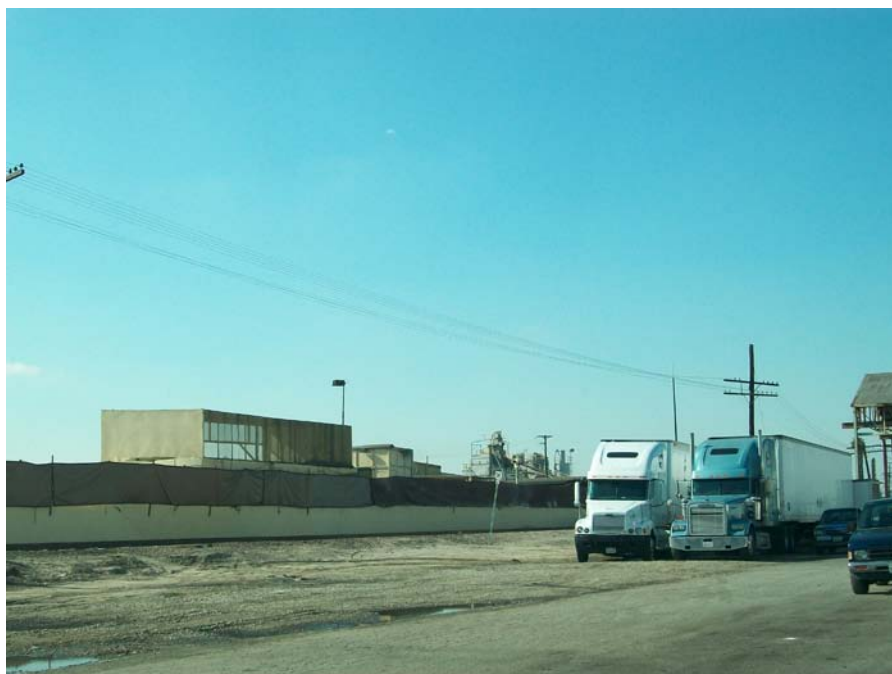
Photograph 3: Jervis facility displaying areas of the site where there is no pavement. Pooled water is visible in the bottom left corner of the photograph.
